A Tough MDEA Example of What SigmaPure Can Do

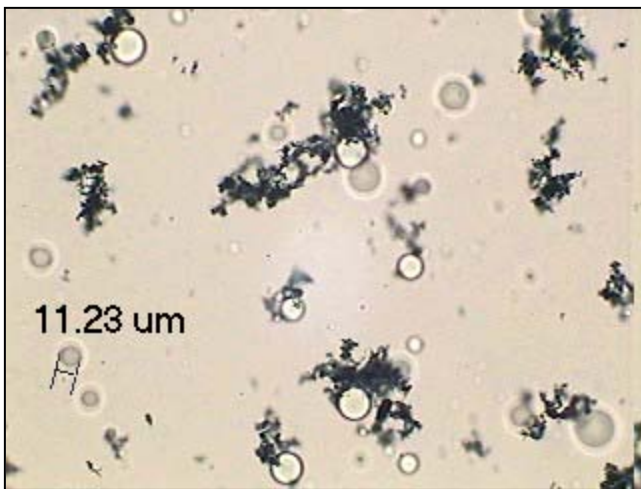
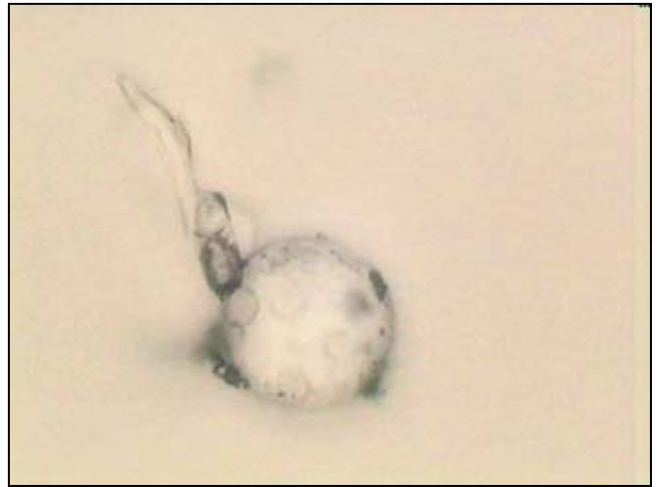
The solution was very turbid and loaded with suspended solids. When allowed to sit for a few hours, solids began to settle to both the bottom and the surface of the sample bottle. Microscopic examination of the floating settlant is shown below (left). The bulk sample looked the same way, but with much smaller agglomerates. The individual iron sulfide solids averaged 0.5 microns when not agglomerated with the immiscible liquid(s). Upon closer examination (top right pg 2.), the immiscible liquid bubbles were made up of at least two, and probably more, immiscible liquids (bubbles within bubbles). Droplets below 1 micron had adsorbed solids.

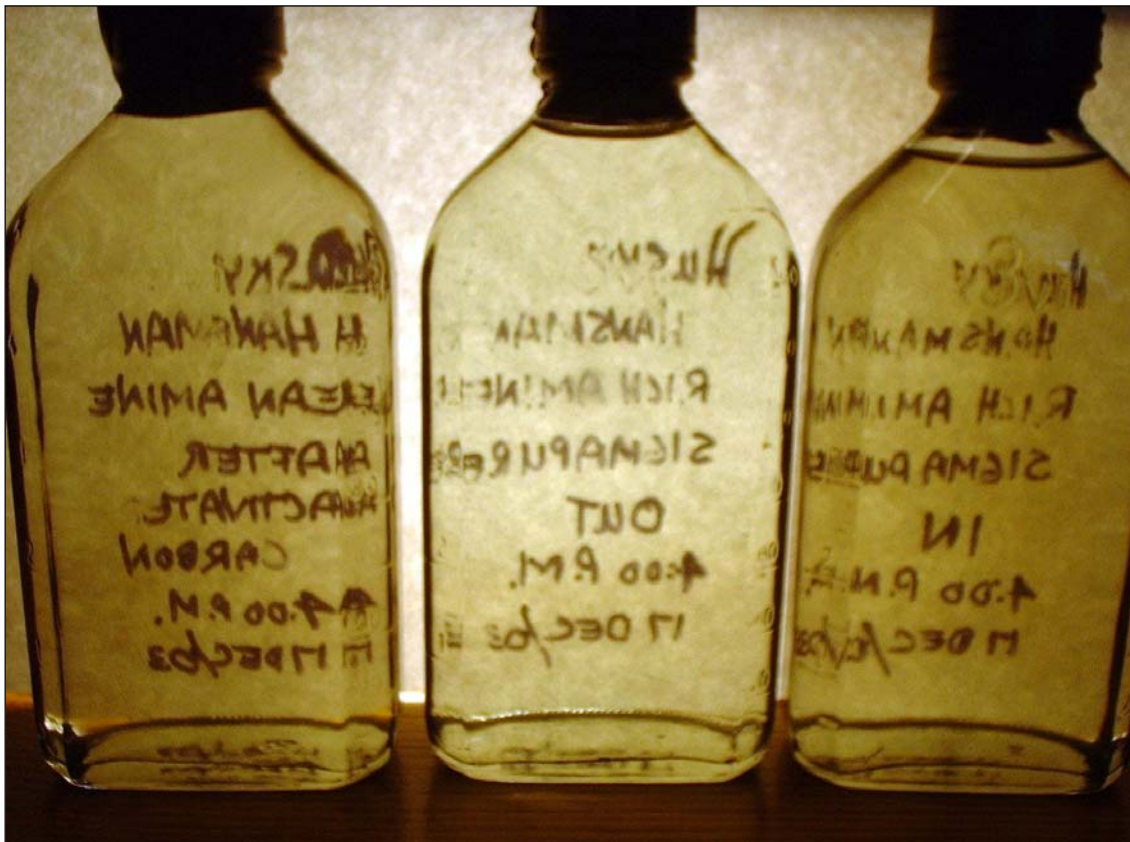
The SigmaPure unit had been operating a week when the samples below were taken. The photo was taken of the back side of the samples to demonstrate optical clarity. The bottle on the left is lean post activated carbon. Obviously it's not doing much. The bottle on the right is the SP unit feed. The SP discharge is in the middle.

The plant had completely eliminated antifoam injection within 6 hours of SigmaPure unit start up. However, the filter changeout frequency had not improved. The plant had just installed a high efficiency inlet gas coalescer that immediately began to collect pipeline liquids. However, as is shown in the feed sample above, the color was still green, indicating solids. Microscopic examination showed a significant reduction in liquid hydrocarbon/solids agglomerates, but they hadn't completely been removed. The hydrocarbon was inhibiting the particle removal efficiency of the SP unit by keeping them from being incorporated in the foam.

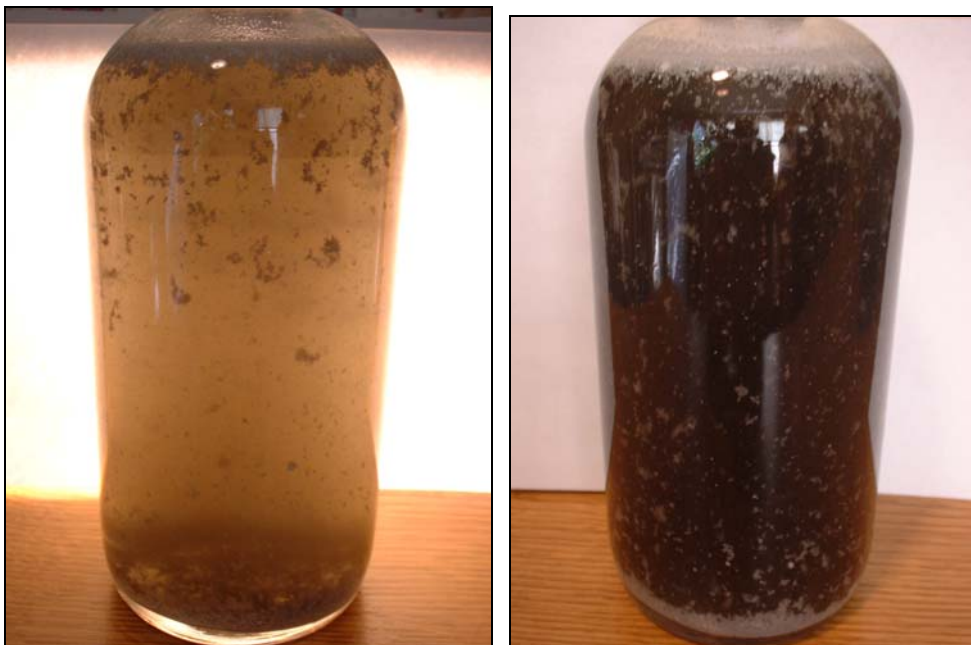
The photos below are of the reflux water (one back lit, the other not).

Microscopic examination showed what was really going on. The large white flakes were too dense to photograph under indirect light, but consisted of solid, white material saturated with immiscible liquid bubbles.

It turned out that the immiscible liquids were concentrating in the reflux drum and being introduced slowly as carryunder to the rest of the system from the regen tower. Increasing the reflux temperature eliminated both the regen foaming and filter problems. SigmaPure waste analysis showed primarily carboxylic acid degradation products, liquid hydrocarbon, and heat stable salts. The solids were iron sulfide.

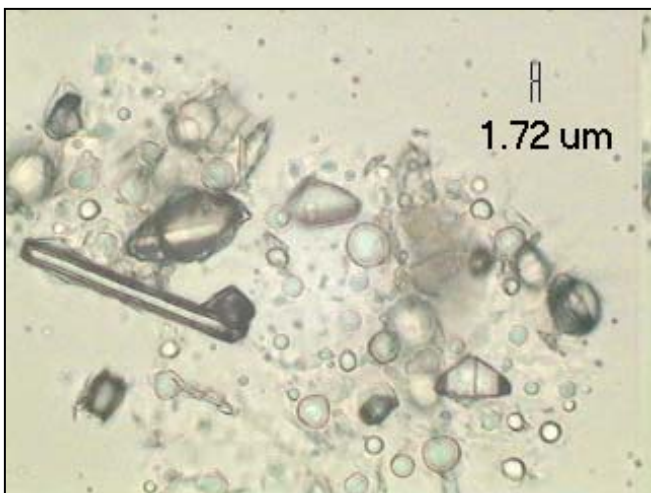
Most of the white solid material melted when the sample was heated to 104 °F. The photos below are of the 104 °F sample cooling to 80 °F. Although certainly not quantitative, the experiment showed that there were definitely multiple immiscible liquids, some of which crystallized below 104 °F. The material was probably mixed paraffin.

This photo shows a nest of solidifying liquids, liquids, and solids clumped together. When this thing was finished it looked like a Swiss cheese of solid paraffin and solids with immiscible liquid filling the holes.

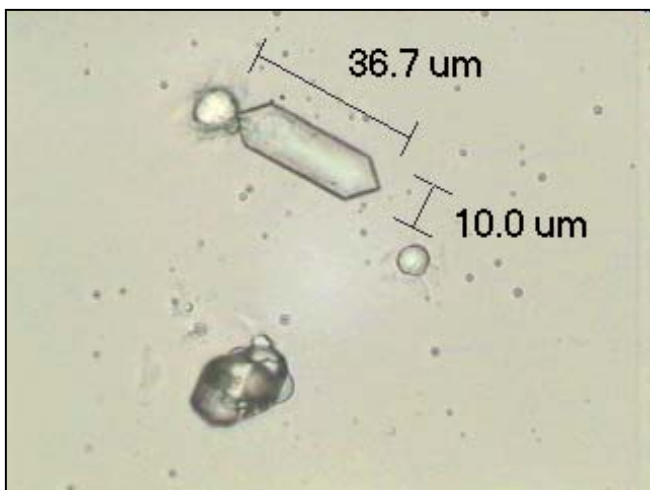
The bubble at the end of the largest crystal is solidifying like the first one in this series. It's obviously something different. There are also droplets that don't appear to solidifying.
