# Sweetening Process Foaming and Abatement Part II: Case Studies

Prepared for Presentation At  
The 2002 Laurance Reid Gas Conditioning Conference  
Norman, OK  
February 24-27, 2002

It was established in part I, that the contaminants that cause amine solvent foaming were incorporated in the foam itself. A device was constructed that used a nonoxidizing gas to concentrate the foaming contaminants, separate the foamate from the amine, and collect it for discharge and analysis.

Part II of this study describes the field results from using this device in gas plant and refinery applications. Descriptions of the plant problems, and how the device performed in each case are reported.

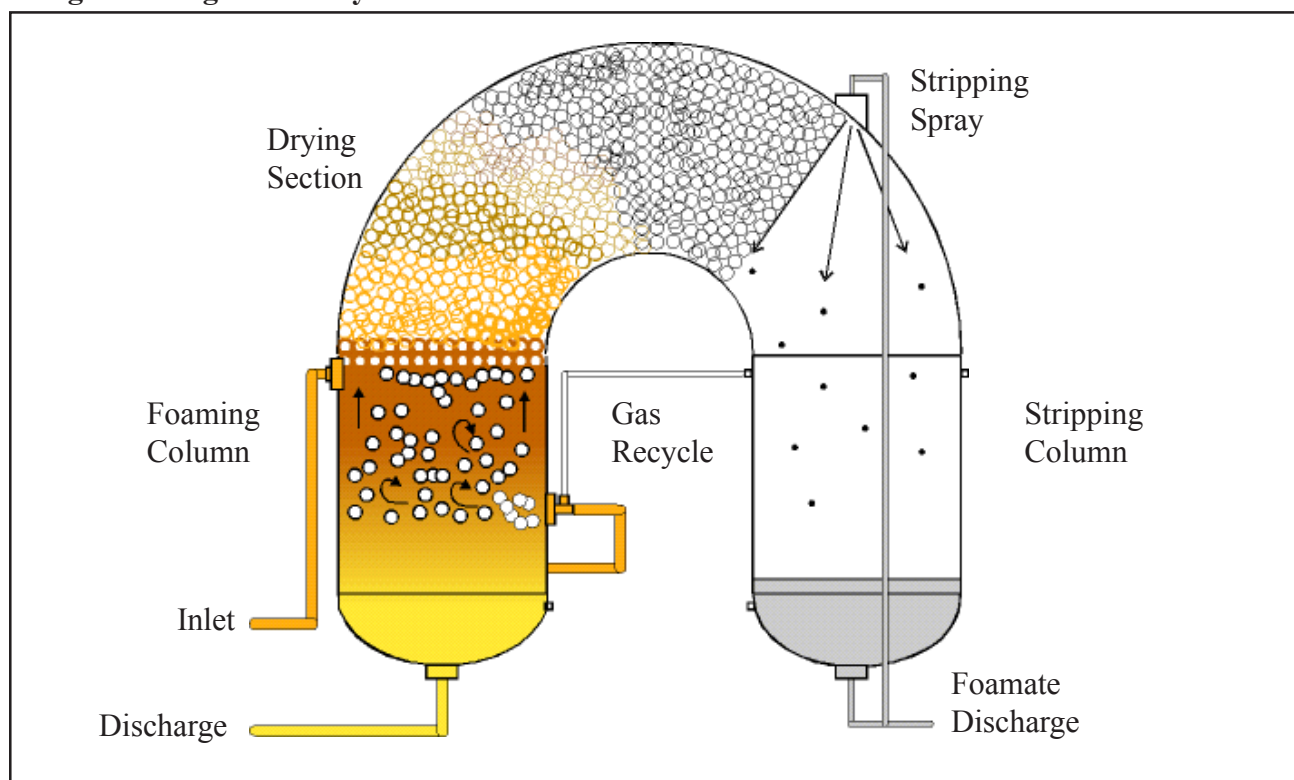
**Figure 1. SigmaPure System**

Recognizing the nature of the contaminants actually responsible for the formation of foam led to the development of a device for their separation. (see figure 1) The strategy was to "pre foam" the amine by introducing a cascade of nonoxidizing gas bubbles into the unit's foaming column. Any soluble or insoluble contaminant that participated in foam development would be incorporated in the foam structure formed at the bulk gas - liquid interface, and consequently separated from the amine. As the foam was displaced up the column into the drying section, clean solvent held in the structure would be allowed to drain back into the foaming column and recovered. The dry foam would be broken by the stripping spray. The spray droplets would coalesce the liquid fraction of the foam, and settle into the sump for recycling as spray or discharged as foamate. The released foaming gas would be recycled to the foaming column and used again.

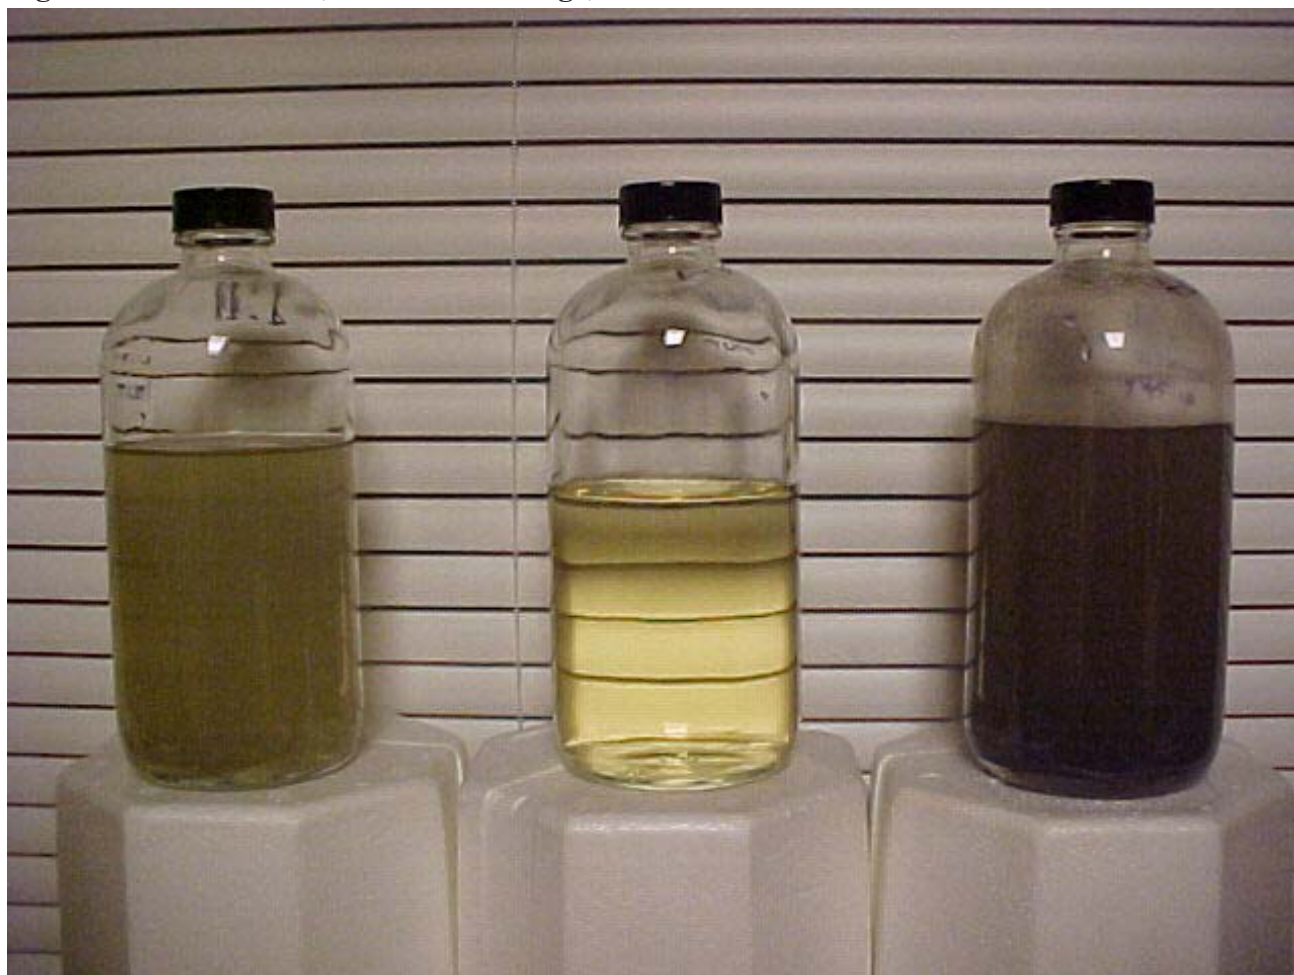
**Figure 2.0 Case 1 Inlet, Treated Discharge, Foamate**

The SigmaPure unit was allowed to operate for approximately 1 hour before samples were taken. The picture in figure 1 shows the condition of the inlet and discharge amine. The foamate sample shown was taken at the end of the run.

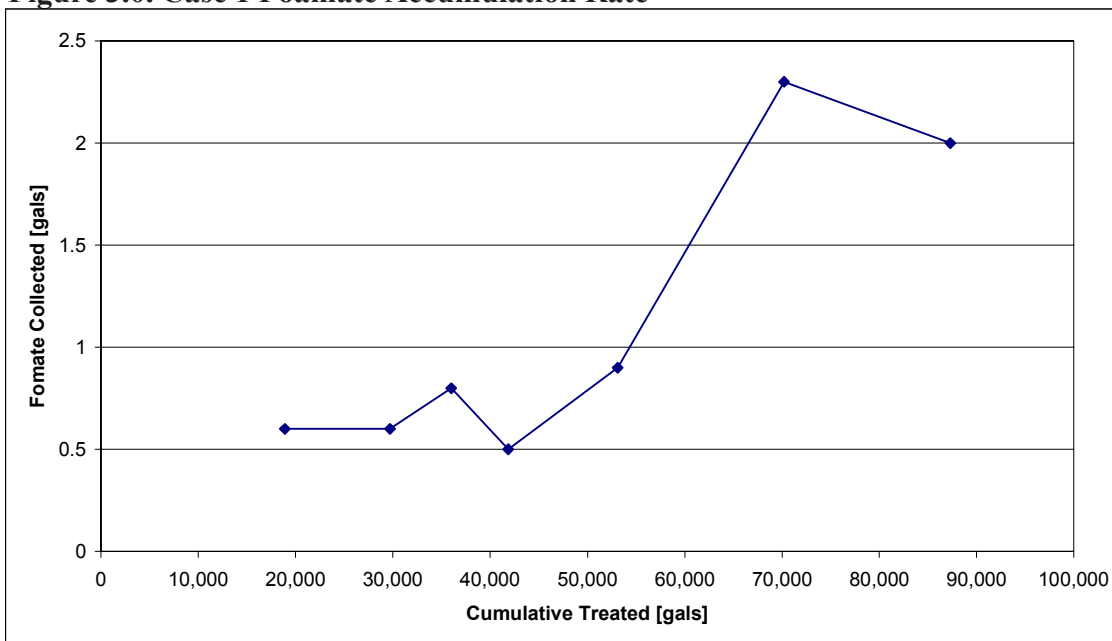
**Figure 3.0. Case 1 Foamate Accumulation Rate**

After 4 hours of operation, the liquid level in the stripping column began to slowly increase, indicating that the foamate was indeed being collected. Foamate accumulation rate was recorded with total amine treated. These data are shown in table 3.0. The system was operated for approximately 10 hours daily for 5 days, resulting in the collection of 6.19 gallons of concentrated foamate from 87,300 gallons treated.

Figure 3 clearly shows that the foamate accumulation rate began to increase after the concentration of amine was increased. This indicated that surfactants were coming from either the make up water, the amine itself, or the associated vessels. There was no reported loss of solvent activity or absorber efficiency when the surfactants were removed from the recirculating amine, so the contaminants were probably not an intended amine fraction.

The surfactants contaminating the system made a dramatic jump between 50 and 70K gallons. The only change made in the plant during that time was a 15% increase in gas rate to the absorber. The differential pressure had reduced and remained steady for three days, so it was decided to increase the rate. The conclusions were obvious. The bulk of the foam causing contaminants were entering the system with the inlet gas, added to a small amount from the solvent make up system.

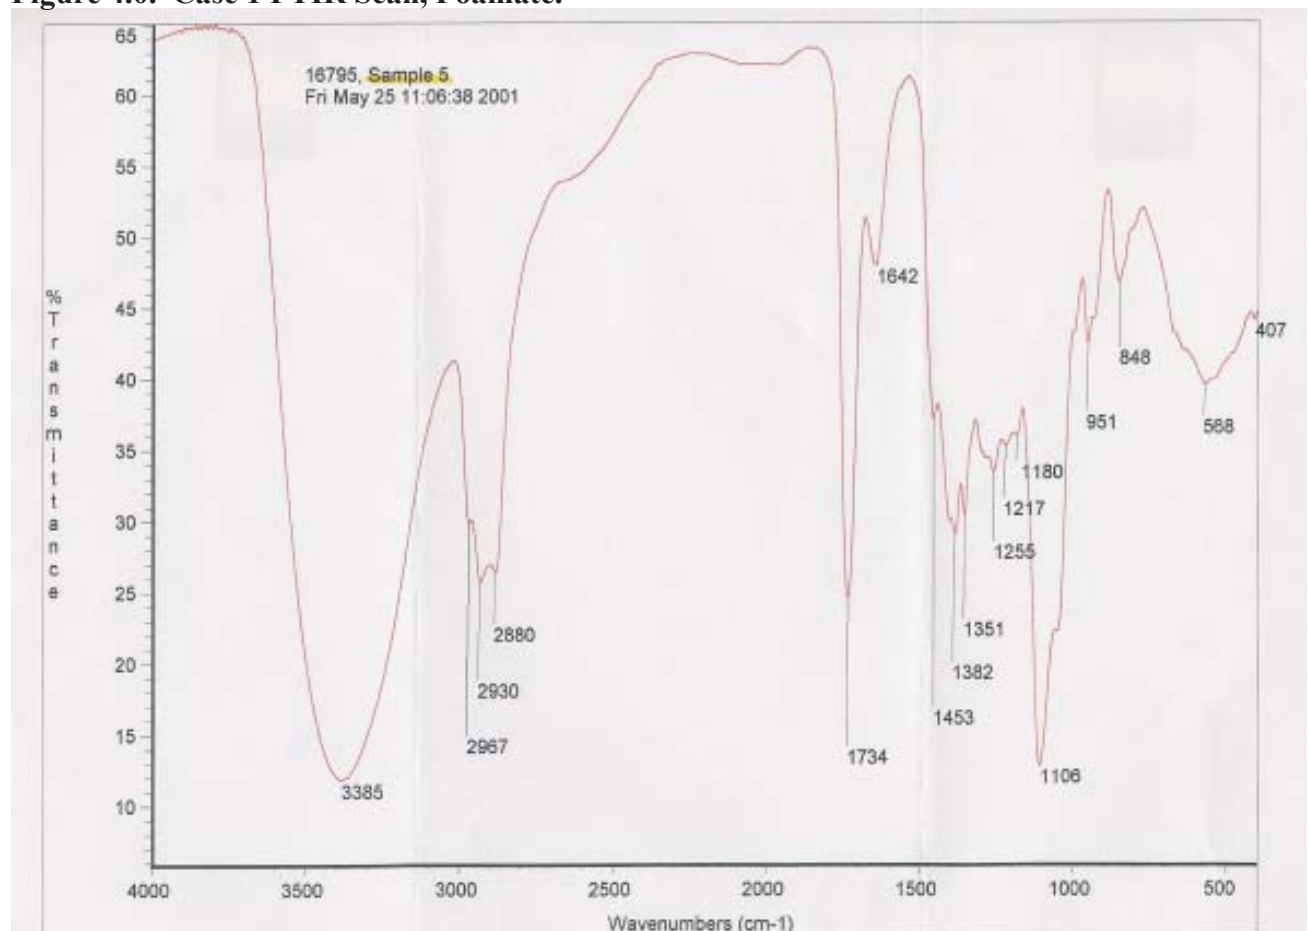
**Figure 4.0. Case 1 FTIR Scan, Foamate.**

Figure 4.0 shows the results of an FTIR scan of the foamate (twice foamed). Table 2.0 shows the identification of the peaks shown on the scan. The peaks represented the functional groups of the organics detected by the scan. Table 3.0 shows the breakdown, by % concentration, of the compounds identified. Breaking the data out in this manner made it easy to determine the most concentrated fractions of the foamate. It follows that the most highly concentrated compounds found in the foam would be those that were most responsible for its development. These are the compounds that were incorporated in the foam structure, therefore should be the foam causing agents.

In this case, short chain carboxylic acids, sulfonates, and ethoxylated alcohols were found to be the culprits. Previous analytical work performed by the plant identified the most probable foam causing contaminant to be glycols detected in the inlet gas. Obviously, this was not the cause of their foaming problems. Short chain carboxylic acids were most likely coming from amine degradation.

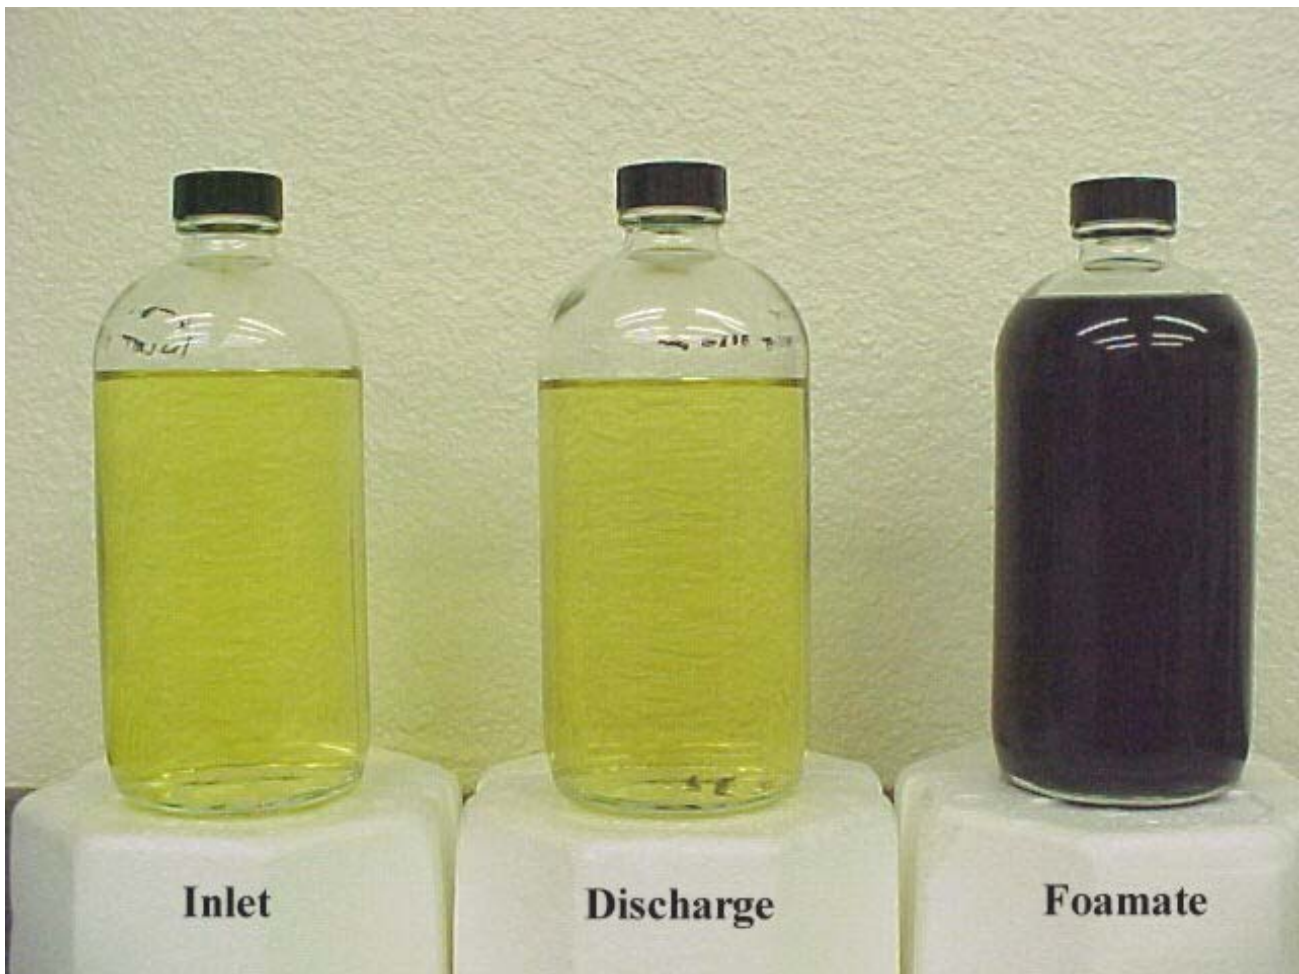
**Figure 5.0. Case 2 Inlet, Treated Discharge, Foamate**

taken. As can be seen in figure 5.0, there were almost no visual differences in the inlet and discharge samples. We were literally shocked when we took the foamate sample, on the right, at the end of the two day run. However, when the plant engineering supervisor showed us an identical carryover sample taken during a previous massive upset, we were reassured that the sample was representative.

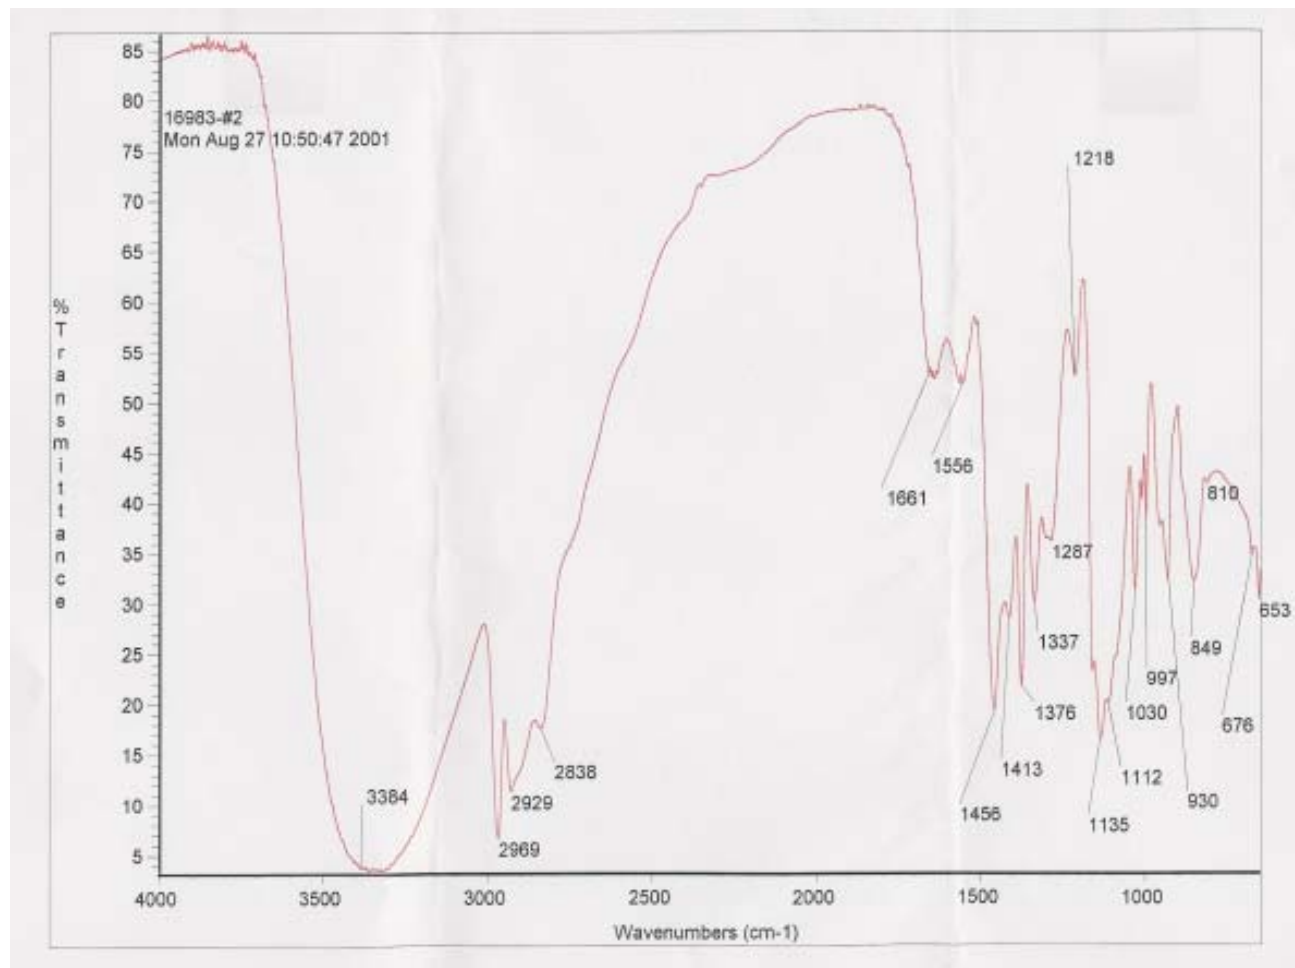
**Figure 6.0 Case 2 FTIR Scan, Foamate**

Table 8.0 represents the scan data broken out in percent concentrations. Although not foaming enough to cause hydraulic problems in their towers, the surfactants present consisted of long chain carboxylic acids, sulfonates, ethoxylated alcohols, and glycols. We were also confident that, although the DIPA wasn’t causing a problem at that time, we were showing the contaminants that were causing their periodic problems. Further, we hadn’t seen long chain carboxylic acids in an amine sample before, so we suspected them to be one of the mysterious foaming culprits. We turned

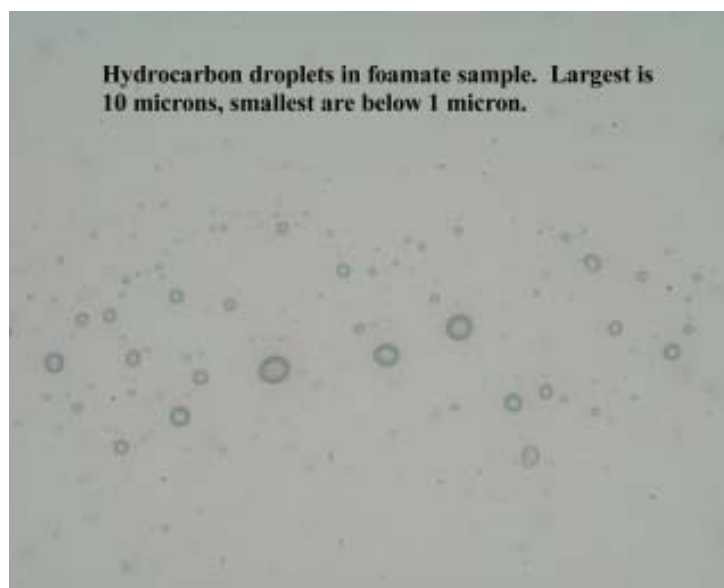
**Photo 1.0 Case 2  
Foamate**

Case 2 photographs 1 and 2 represent the contaminants found in the foamate samples. Photo number 1 showed, what we believed to be, the source of the soluble long chain carboxylic acids in the foamate. These are microscopic droplets of entrained liquid hydrocarbon. By itself, the hydrocarbon wouldn't cause foaming. However, soluble fractions or soluble degradation products produced as the amine was stripped would account for the fatty acid surfactants.

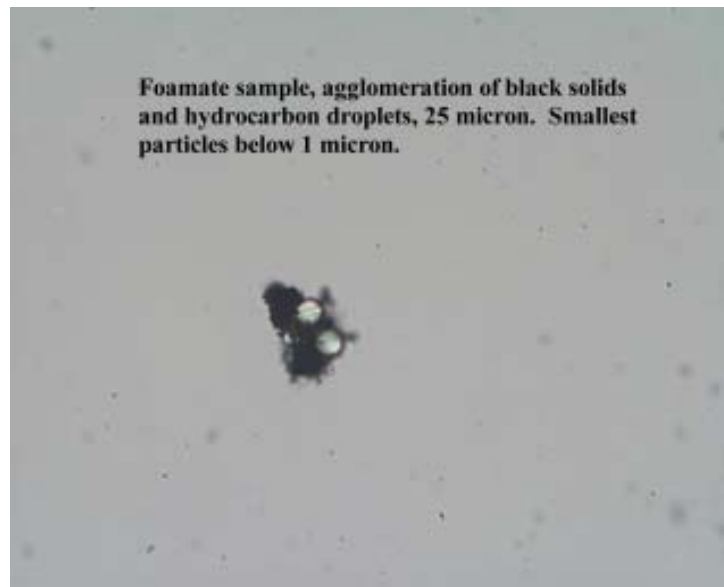
**Photo 2.0 Case 2  
Foamate**

Photo number 2 shows a common occurrence when immiscible liquids, i.e., liquid hydrocarbon or antifoam and solid particles, are present in amines; namely agglomerates. The small solids are wetted by the immiscible liquid and clump together. This is one of the causes of premature particle filter and activated carbon fouling.

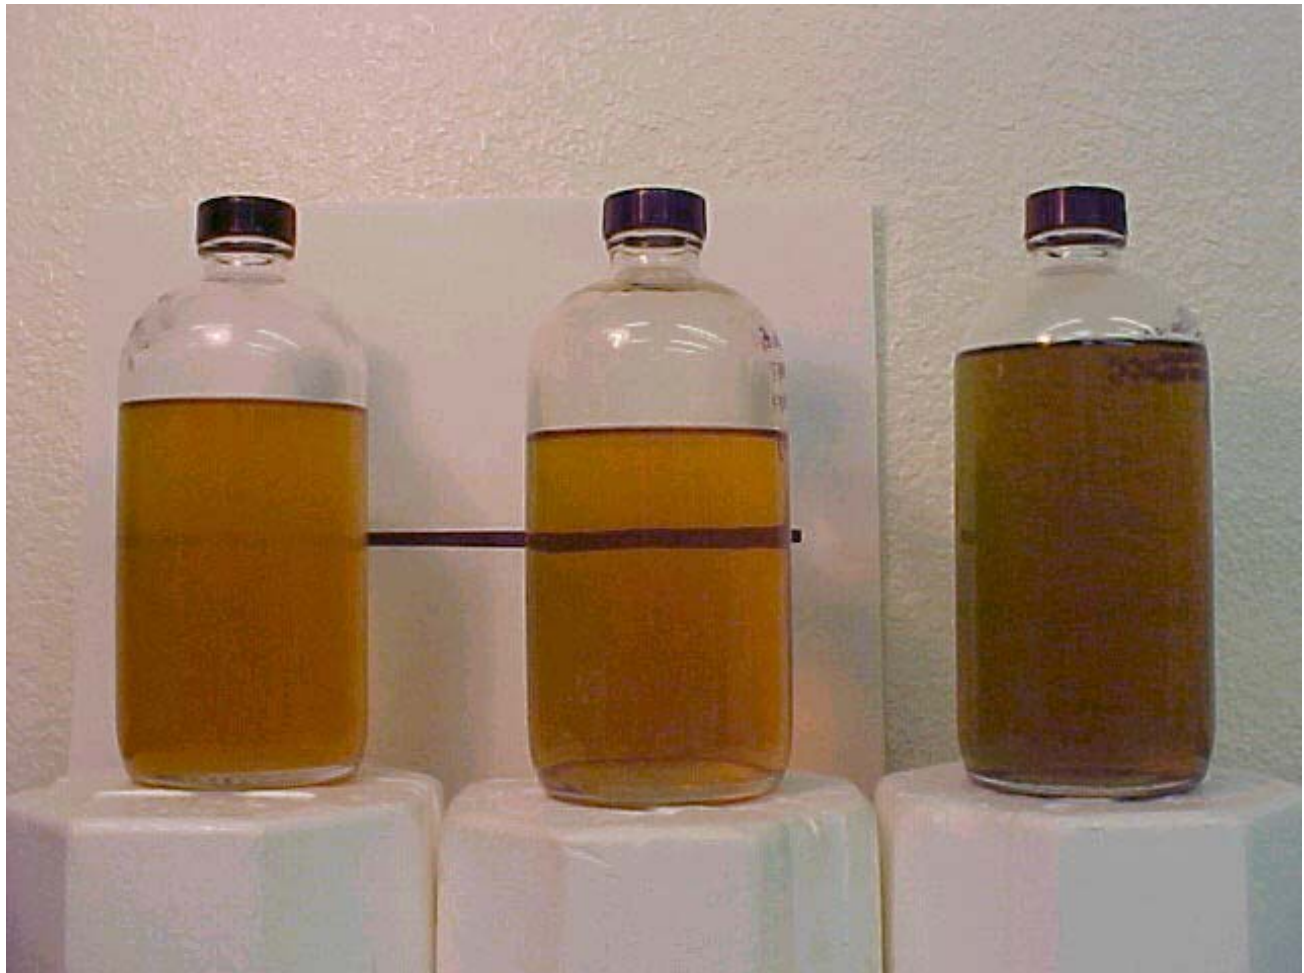
**Figure 7.0 Case 3 Inlet, Treated Discharge, Foamate**

The samples shown in figure 7.0, from left to right, are initial inlet, inlet after two days of treatment, and final foamate. The sampling strategy was to examine what was recirculating through the plant rather than what was being discharged from the SigmaPure System back into the plant. The color of the final inlet sample improved slightly. The optical clarity was significantly improved. There were no obvious suspended solids or immiscible liquids in any of the samples. As has come to be expected, the foamate sample was off color and very turbid. However, again there were no visible suspended solids or immiscible liquids.

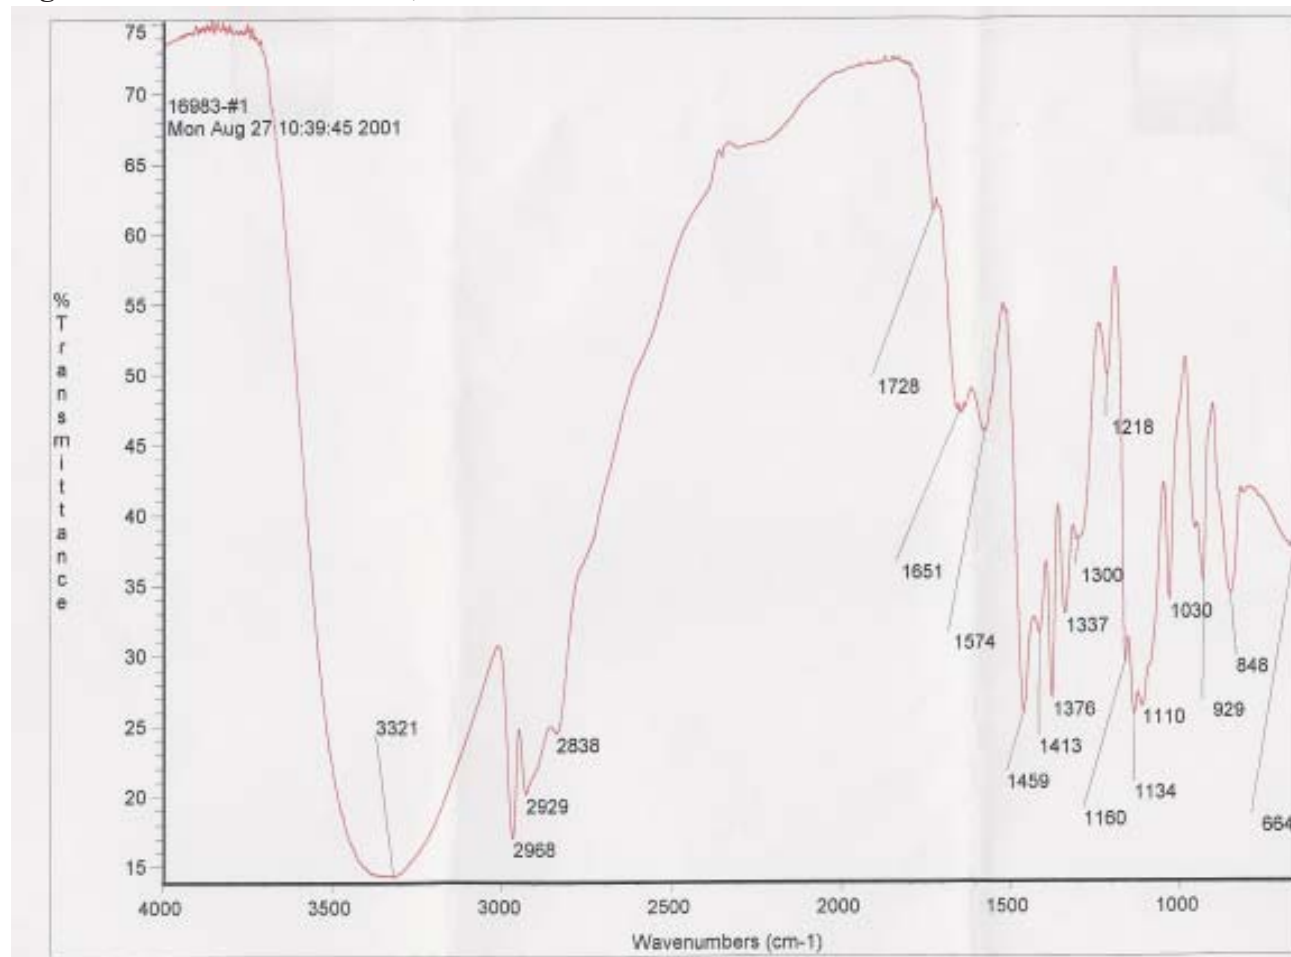
Figure 8.0 Case 3 FTIR Scan, Foamate

These data showed that long chain carboxylic acids were playing the largest foam development role. Sulfonates, ethoxylated alcohols and glycols were also involved as surfactants. It was not determined where the long chain fatty acids were originating. It was speculated that they were amine or, possibly even, antifoam degradation by products. However, to the best of the this author's knowledge, antifoam degradation has never been reported associated with use in sweetening plants.

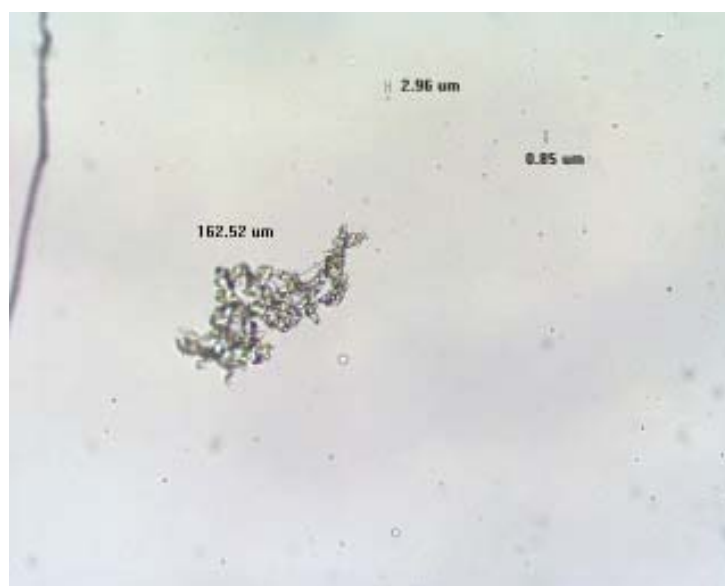
**Photo 6.0 Case 3  
Initial Inlet**

Photograph 6 a picture of a large agglomerate made up of antifoam and suspended solids. A large number of the solids seen in this sample were agglomerates.

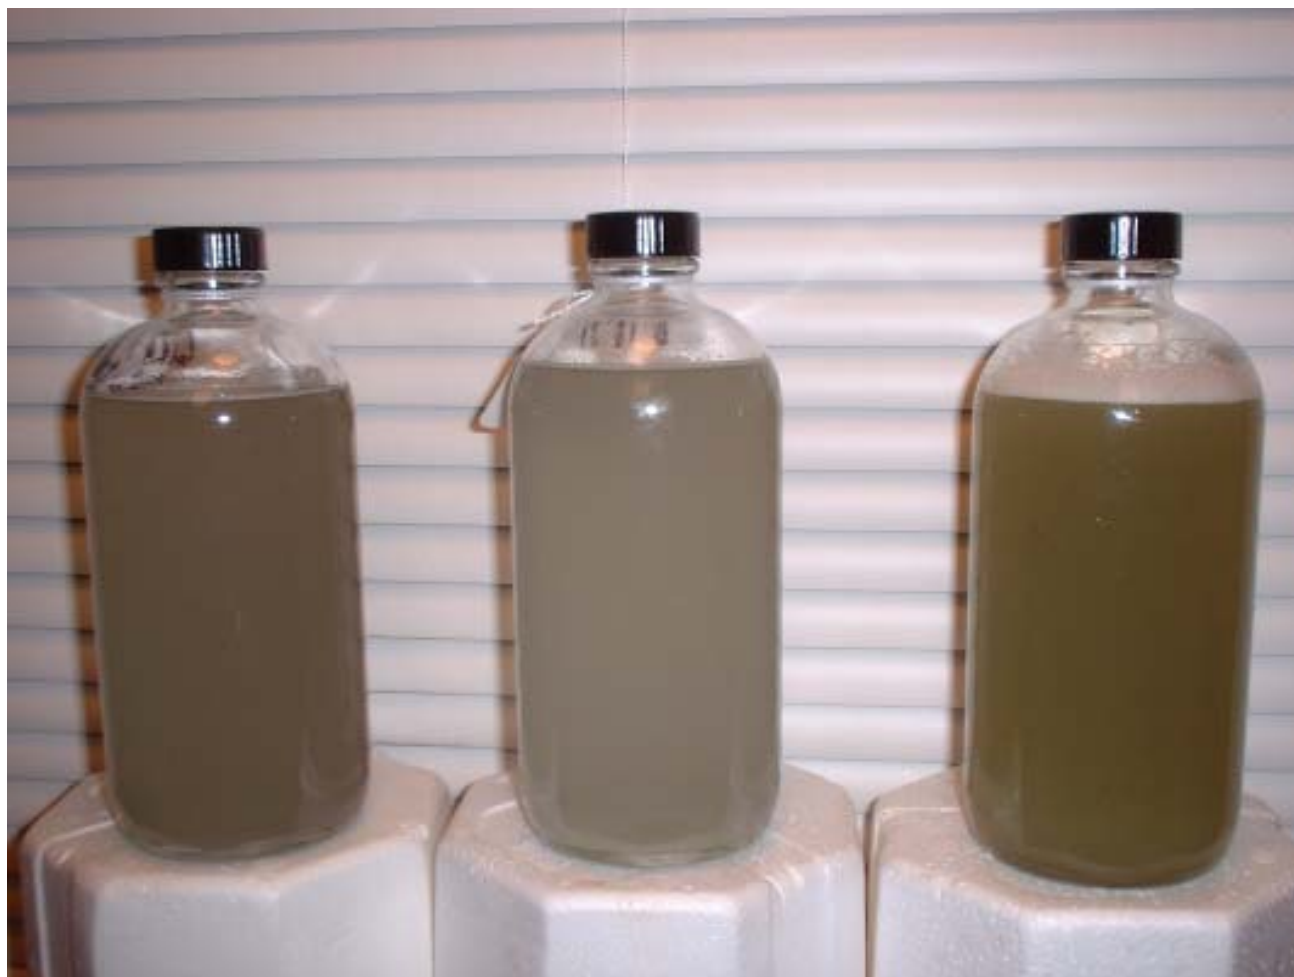
**Figure 9.0 Case 4 Inlet, Treated Discharge, Foamate**

Figure 5.0 shows the condition of the amine. The samples from left to right below represent the initial inlet, inlet after two days of operation, and final foamate. This case represents the first time the SigmaPure System effluent wasn't crystal clear, and is an example of a major advantage of

the system. The solvent components that were not responsible for foaming were not removed. We suspected the cloudiness was due to the antifoams injected into the system. Note the foam on the surface of the foamate sample. This picture was taken several hours after the samples were agitated.

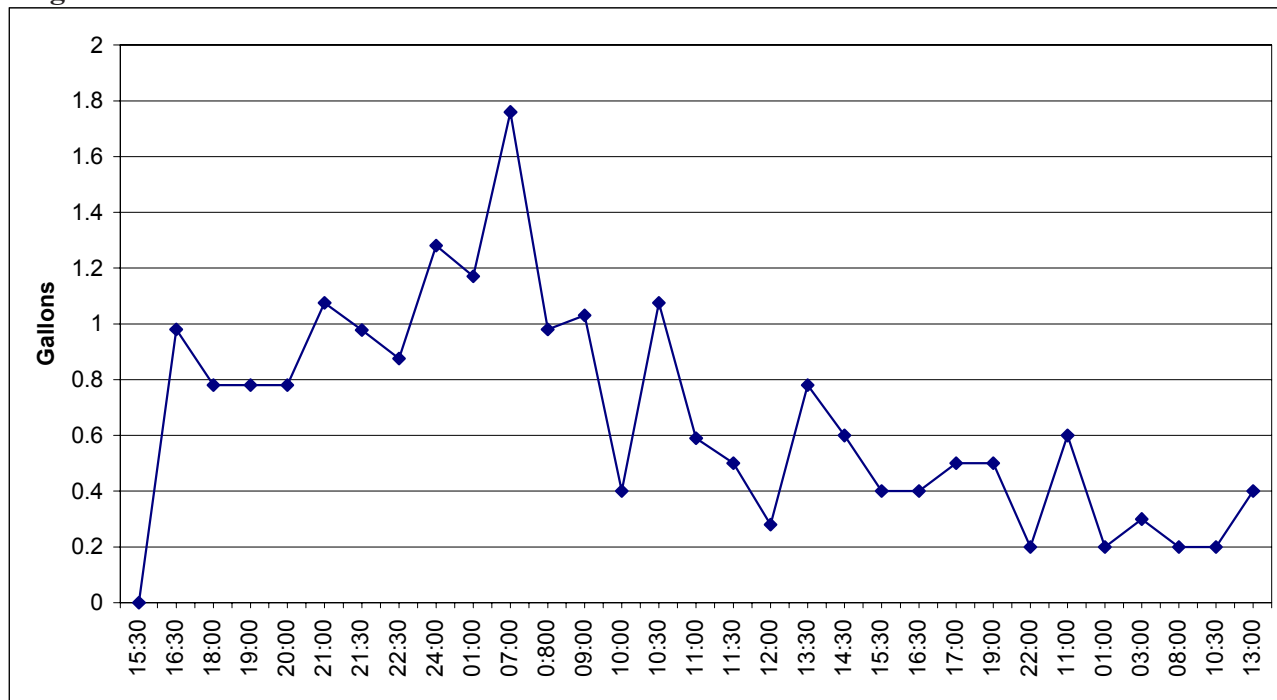
**Figure 10.0 Case 4 Foamate Accumulation Rate**

Figure 10 shows the rates at which foamate was accumulated. The system was obviously cleaning up during the first 11 hours of treatment. The unit was isolated, but running in recirculation mode from 01:00 to 07:00. When flow was established at 08:00, the foamate collection rates trended

downward. At 32 hours of operation, the accumulation rate began to stabilize at 0.2 gallons per hour. This would be the profile of a plant that wasn't being contaminated on a continuous basis. The system was judged to be as clean as it was going to get without putting the SP unit in the plant on a long term basis. The foaming tendency and breaktime had been acceptable after 24 hours of operation.

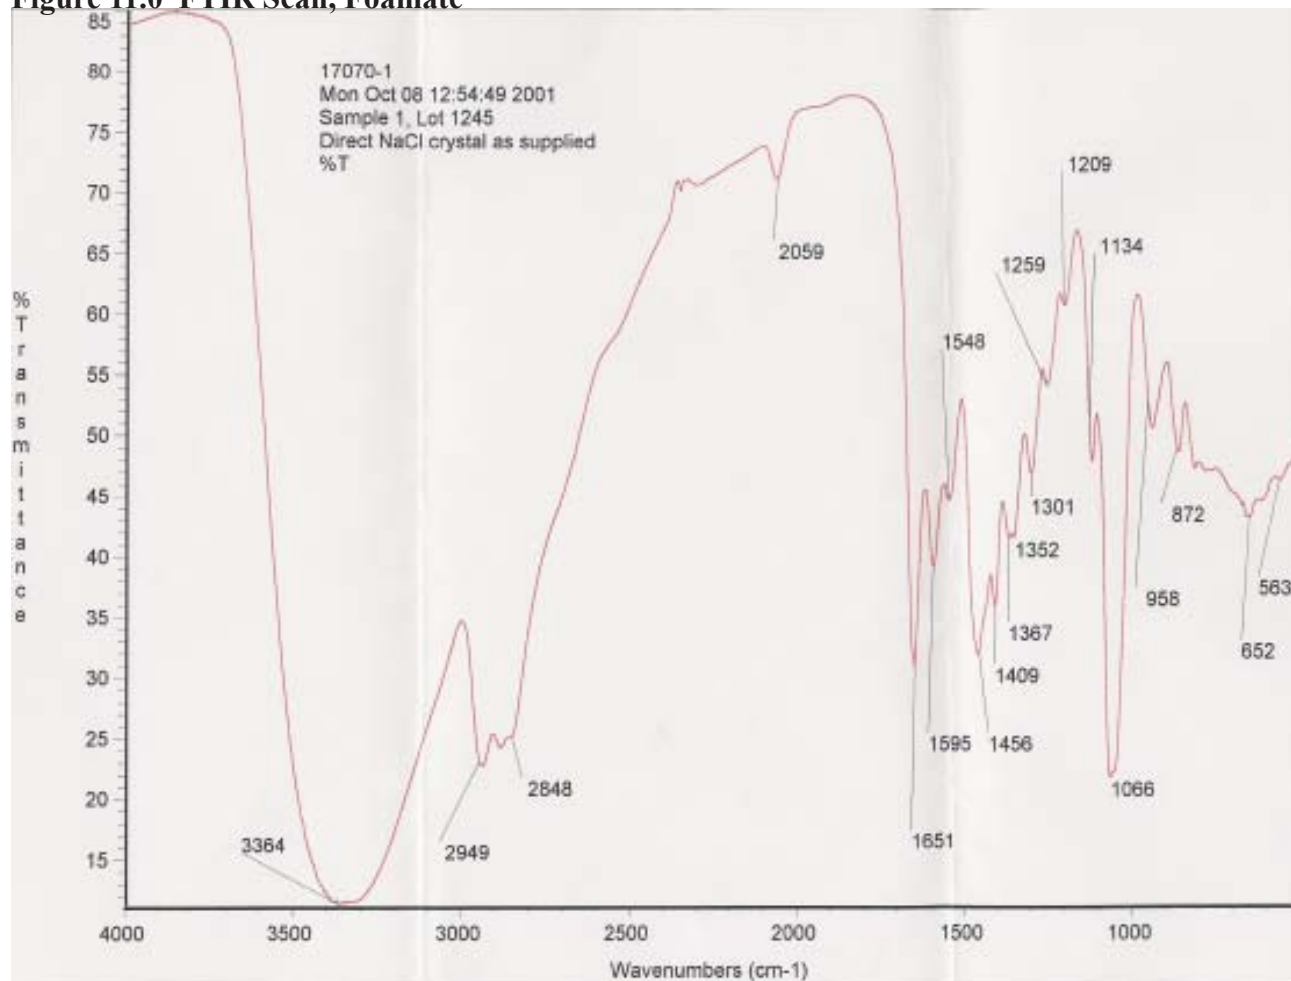
Figure 11.0 FTIR Scan, Foamate

Long chain carboxylic acids represented the highest concentration of all of the surfactants present in the amine. This system was known to see liquid hydrocarbon with the feed gas. As was seen in Case 2, where liquid hydrocarbon was a suspected contaminant and which also showed long chain carboxylic acids, these found in Case 4 could also be liquid hydrocarbon degradation related. However, these long chain fatty acids were also seen in Case 3 where the likelihood of finding hydrocarbon was low. The plant in Case 2 reported to add only small amounts of antifoam, where in Case 3 they added quite a bit. It should be noted that all three plants used alcohol based antifoam. We are not prepared to conclude that these large molecular weight fatty acids were coming from antifoam degradation, but it is highly suspect.

The other surfactants present included a small amount of sulfonates and glycols, with a significant amount of ethoxylated alcohols. It is known that one of the antifoams used in these system contained ethoxylated alcohols.

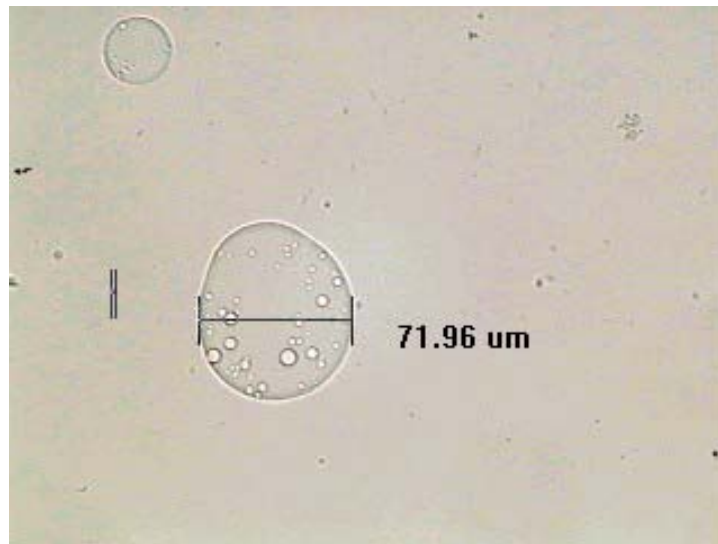
**Photo 7.0 Case 4  
Initial Inlet**

Case 4 photographs 7-9 show some of the more unique contaminants found in these samples. Photo 7 is from the initial inlet, and shows two immiscible liquids with a surface affinity, but high enough surface energies that they didn't coalesce. It isn't known if these are two antifoam chemistries, or a hydrocarbon with an antifoam. The smallest particle shown in the photo is around 2 microns in diameter, and is a solid.

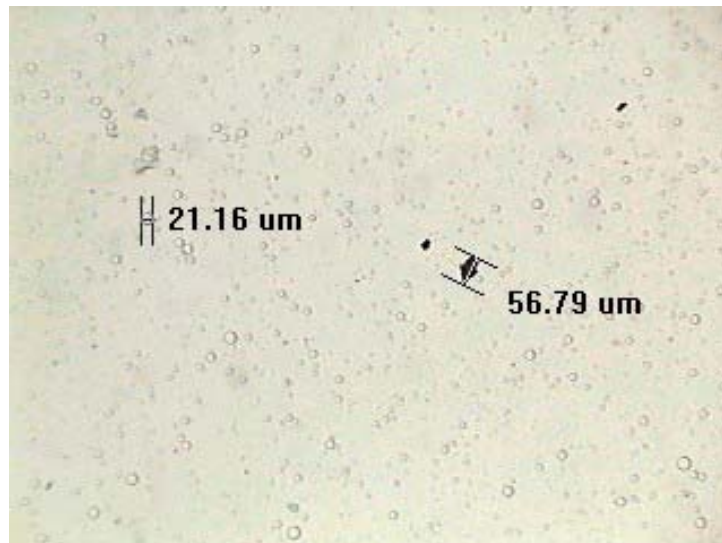
**Photo 9.0 Case 4  
Final Foamate**

Photo 9 shows extremely emulsified immiscible liquid droplets, and larger solid particles seen in the final foamate. There were other examples of large bubbles of immiscible liquids as shown in photo 5.

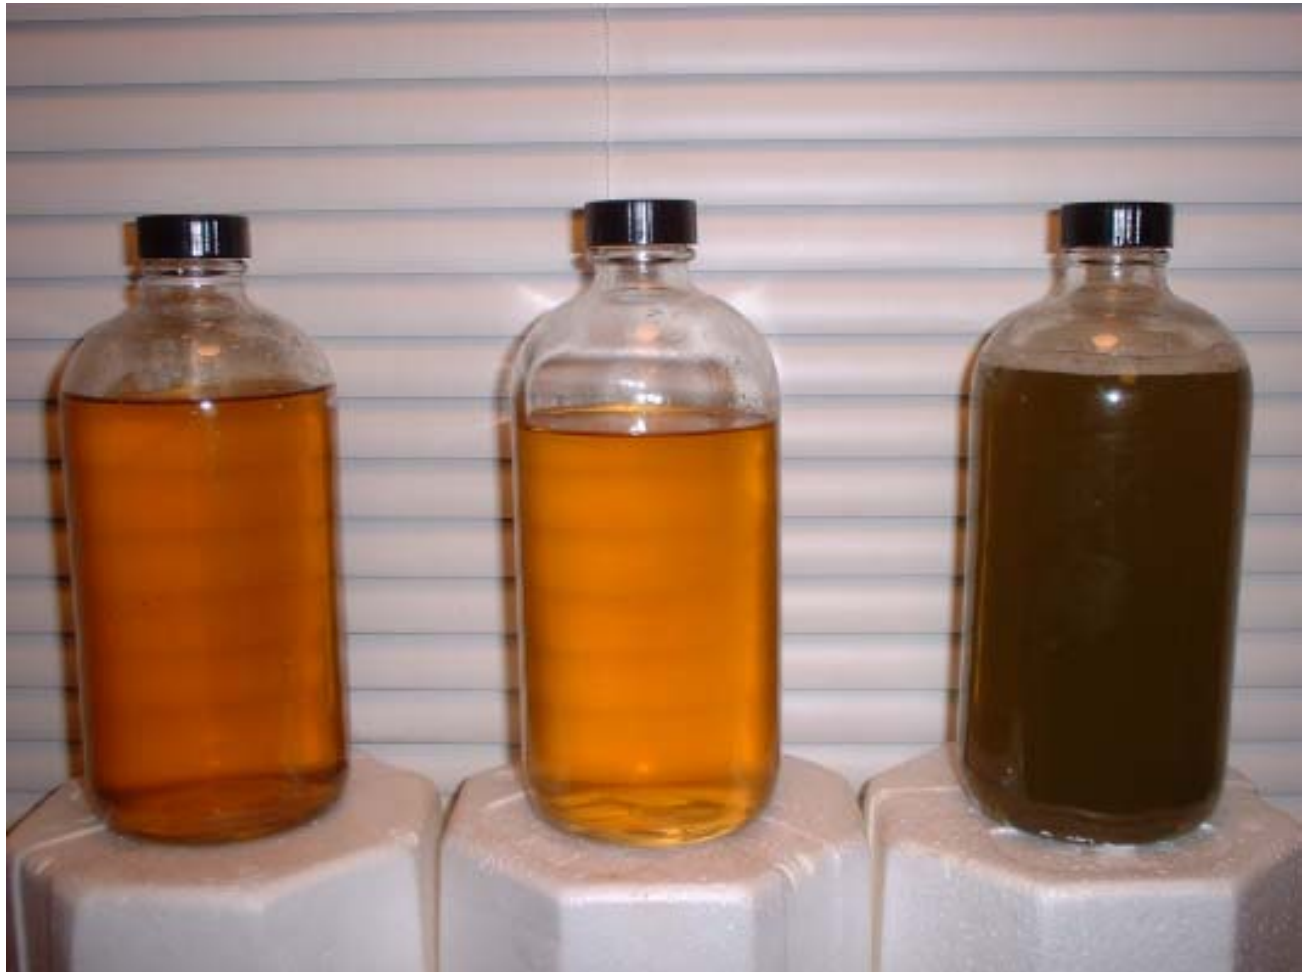
**Figure 12.0 Case 5 Inlet, Treated Discharge, Foamate**

The samples taken are shown in figure 25 below, i.e., from left to right, initial inlet, final inlet, and final foamate. Although the photograph looks a little fuzzy, the initial inlet appeared fairly

dark and turbid. The final inlet was much lighter amber with significantly improved clarity. The foamate was dark green, and very turbid. Note the foam on the surface of the foamate sample. The samples had been agitated about 3 hours before this photograph was taken.

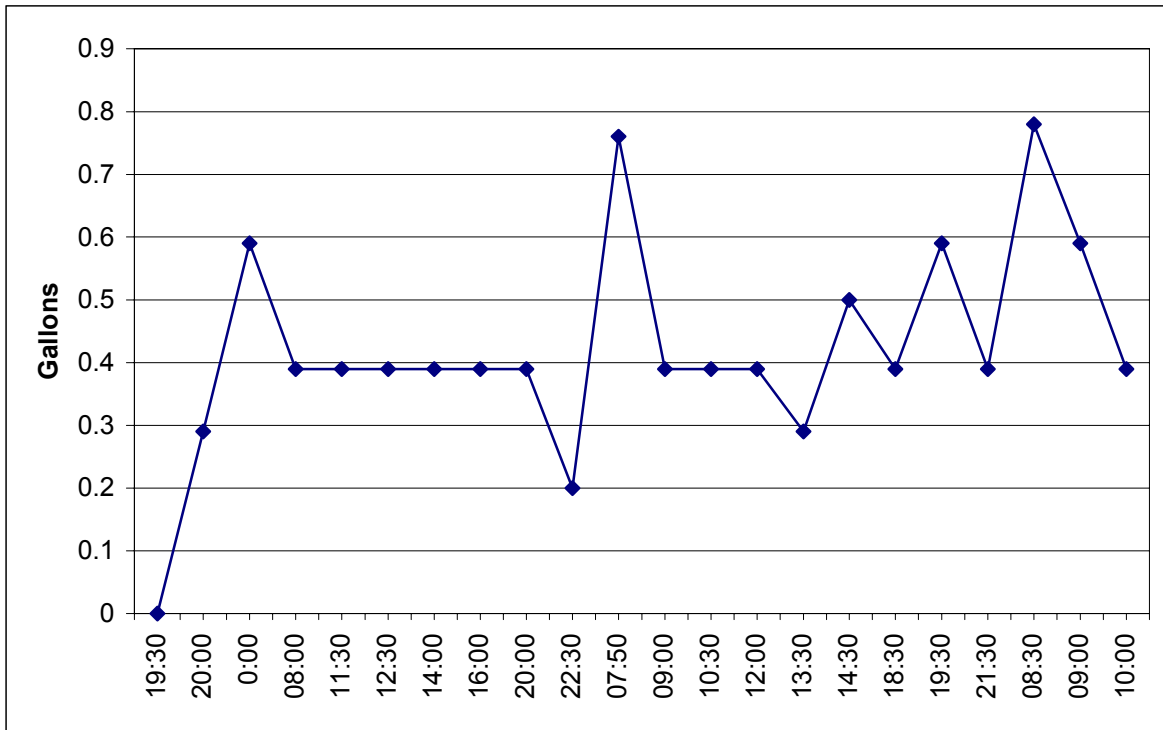
**Figure 13.0 Case 5 Foamate Accumulation Rate**

The graph in figure 26 shows the rate of foamate accumulation. As would be expected, the removal rate increased steadily from 19:30 to midnight. The SP unit collected about 0.3 gallons in the first 30 minutes of operation, and 0.6 for 4 hours thereafter. The removal levels fluctuated at about the same level until 13:30 the next day when the trend began to increase slightly. At that time,

one upstream feed sources was being starting up which caused incredible pressure swings throughout the plant. Despite the variances in pressure, it appeared as though the contaminant ingress to the plant was relatively constant.

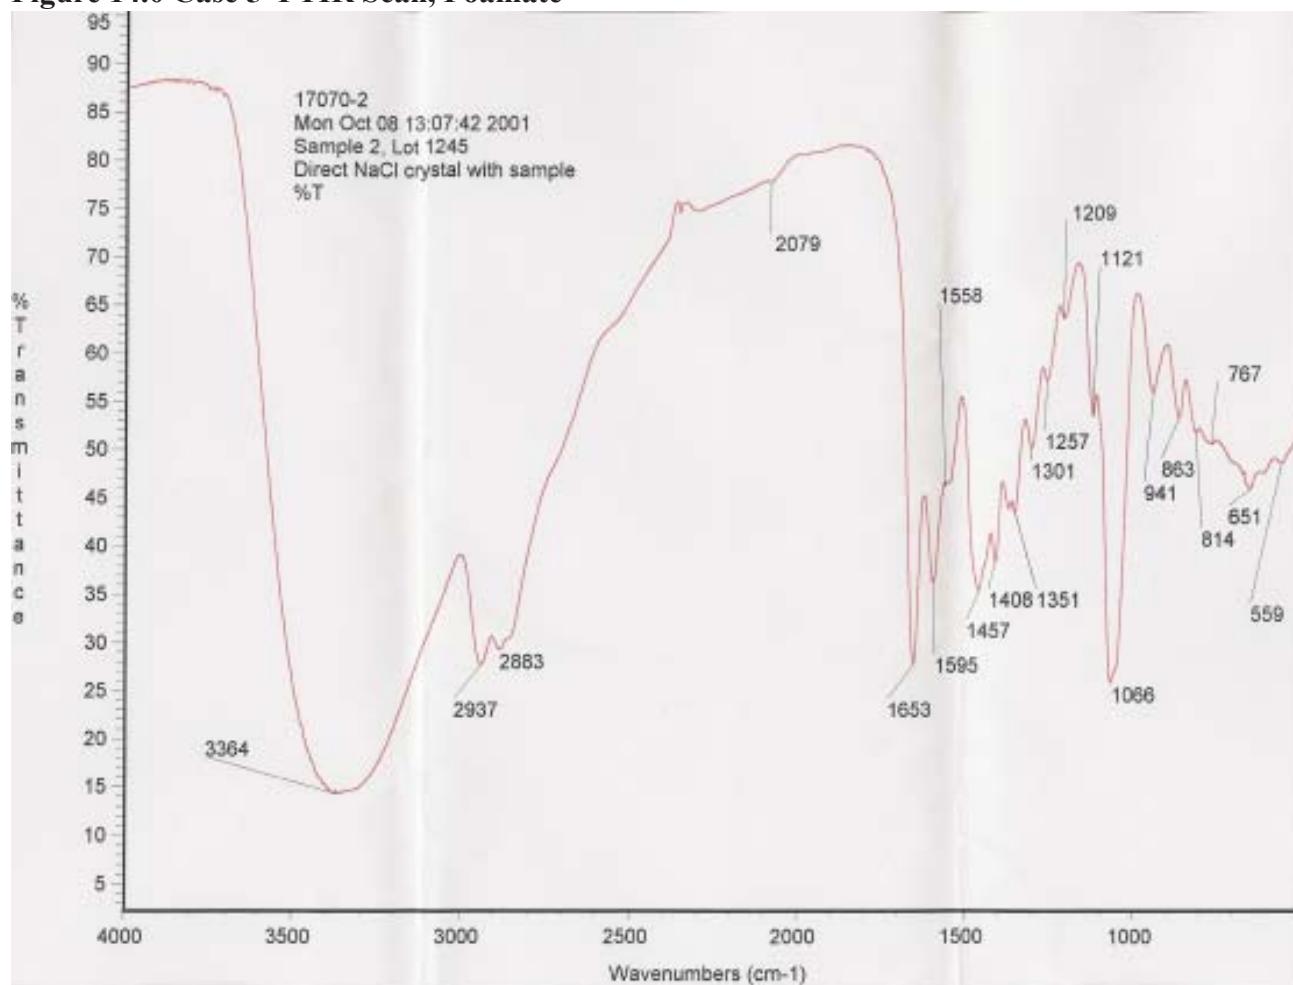
**Figure 14.0 Case 5 FTIR Scan, Foamate**

The surfactants present in the foamate sample consisted of long chain carboxylic acids, a small amount of sulfonates and glycols, and ethoxylated alcohols. The ethoxylated alcohol based antifoam was used in this system, but not nearly to the extent as Case 4. Since this antifoam is being used, it cannot be concluded that the fatty acids are hydrocarbon degradation products.

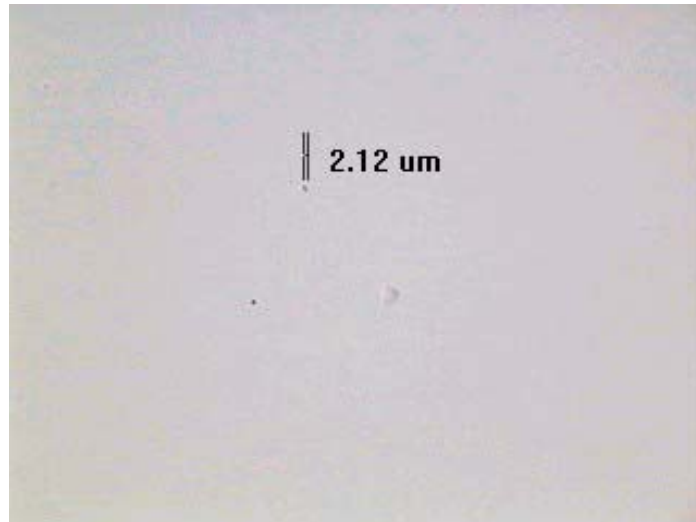
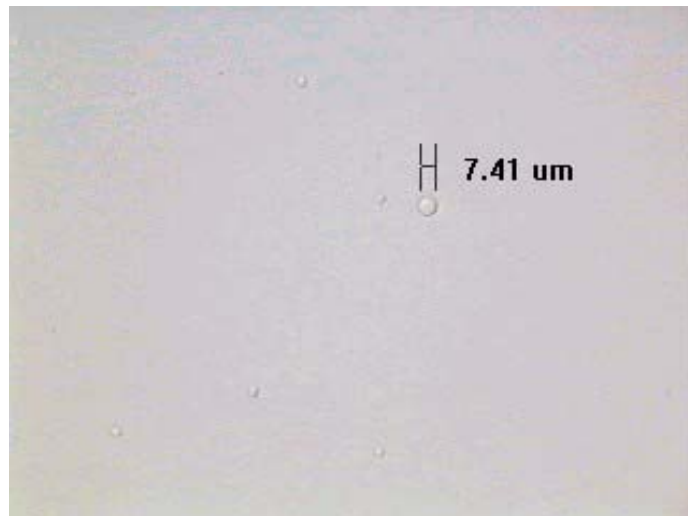
Photo 12 and 13 are of the final inlet shown is of the final inlet. These photos show the condition of the amine circulating in the process after SP treatment. The droplet shown is properly dosed antifoam that wasn't removed.

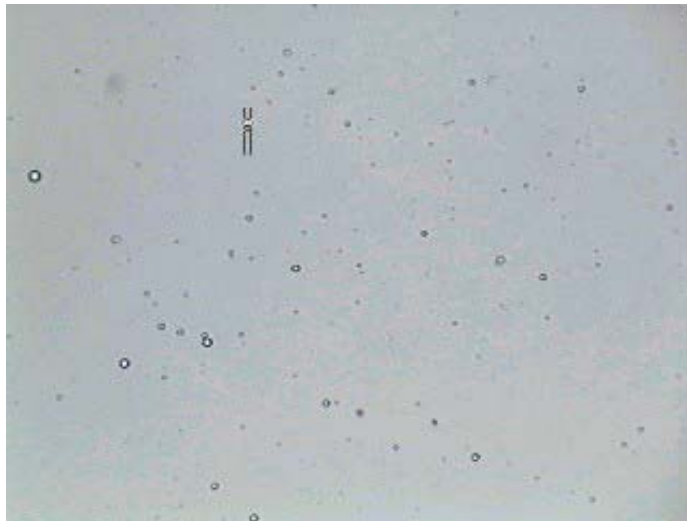
**Photo 14.0 Case 5  
Final Foamate**

Photo 14 is of the foamate. This picture was included to show that even highly emulsified immiscible liquids are removed if they contribute to the foam development. These droplets are probably excess antifoam. The solids shown are well below 1.0 micron in size.
